PROGRESS REPORT

Derry Waterfront Park Living Shoreline
13-044-000-6911
Final Report

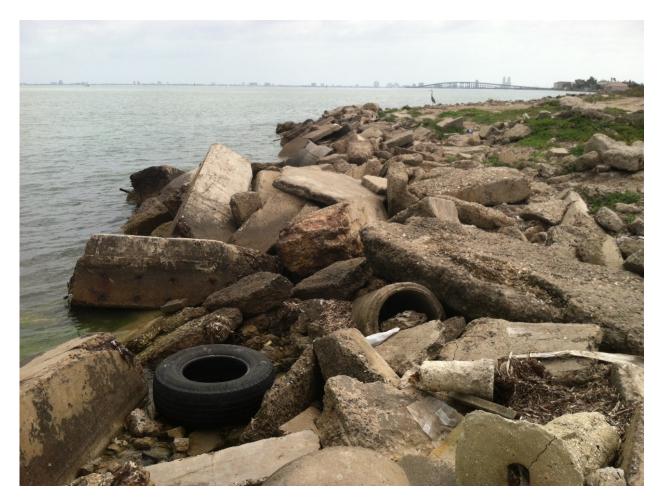
Photo taken on April 22, 2014 of typical shoreline debris prior to construction

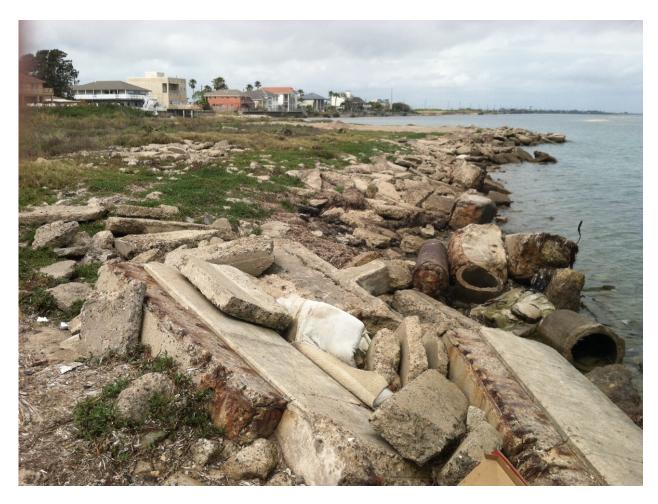
Photo taken on April 22, 2014 of shoreline debris (looking west) prior to construction

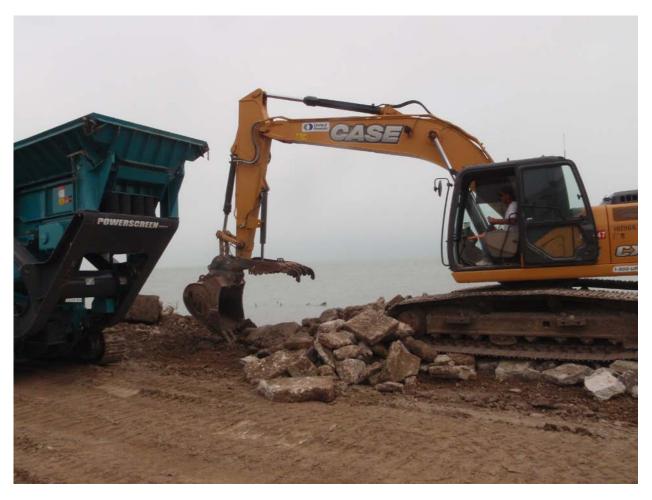
A Notice to Proceed was issued to the construction contractor on April 1, 2015. The construction contractor cleared debris from the shoreline and installed silt fence in the work area. A significant amount of concrete debris was discovered below existing grade in the marsh planting area, which was beyond the limits of shoreline surface debris. The project engineer and construction contractor discussed options to address the issue. The construction contractor broke down all concrete and

Photo of concrete debris removal on April 17, 2015

removed the debris. The breakwater was completed on June 17, 2015. Smooth cordgrass planting began on August 13, 2015 and was completed on August 14, 2015. The substantial completion inspection took place on August 20, 2015.

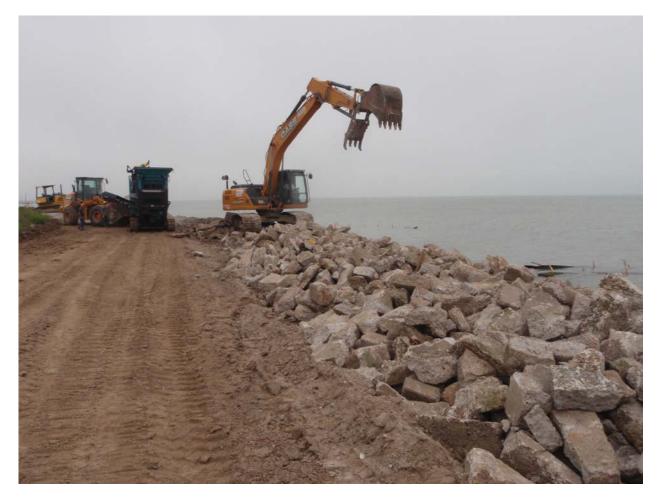
Photo of concrete debris removal on April 17, 2015

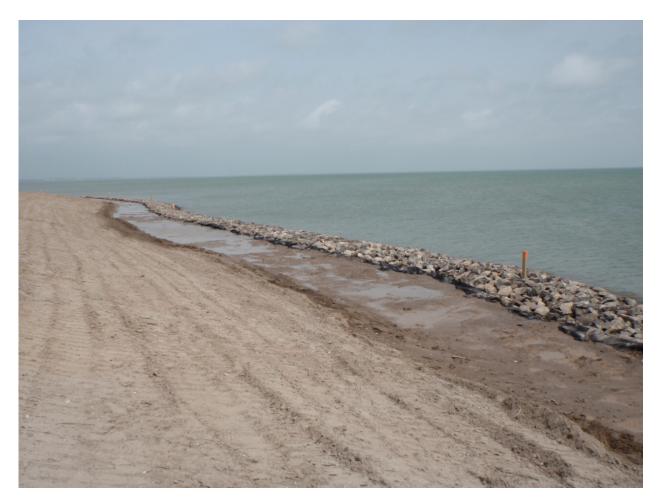
Photo of breakwater and backfill on May 15, 2015

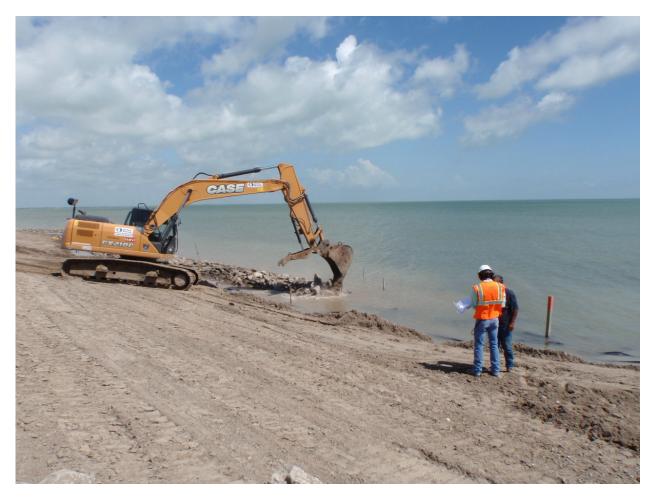
Photo of breakwater construction on June 12, 2015

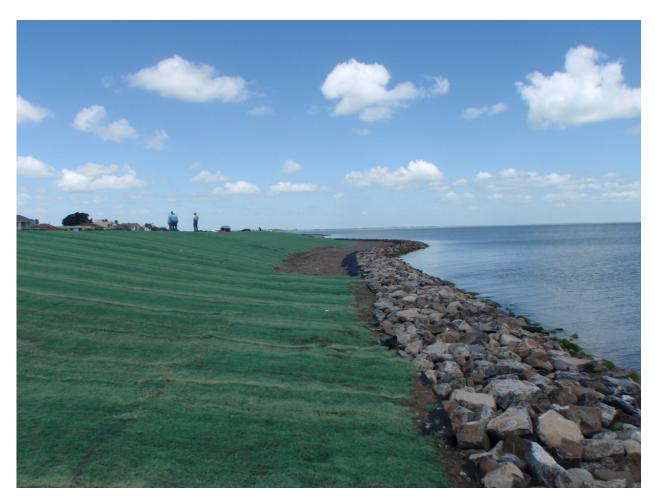
Photo of breakwater and upslope looking west on June 26, 2015

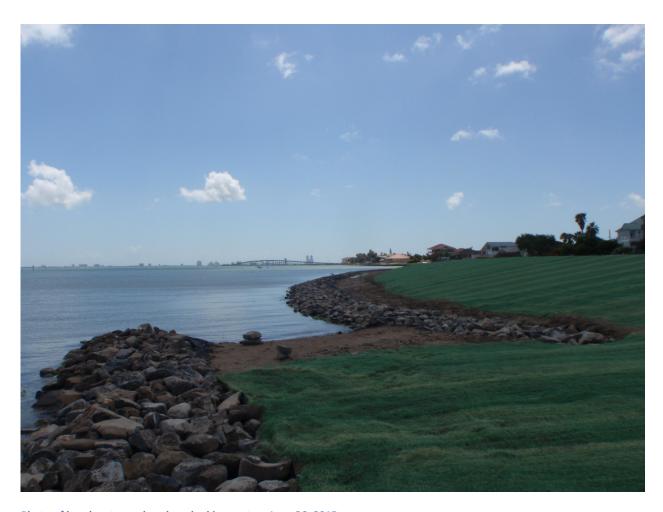
Photo of breakwater and upslope looking east on June 26, 2015

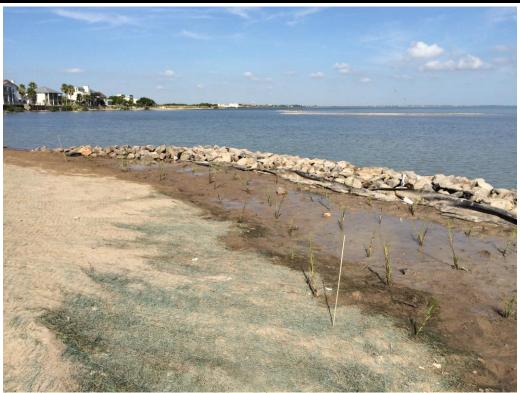
Beginning of marsh planting on west end of project site.

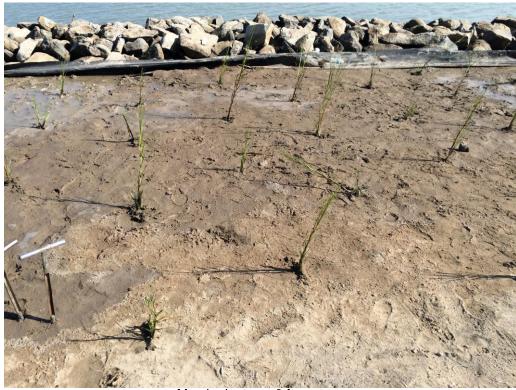
Marsh plants, at 3 ft centers.

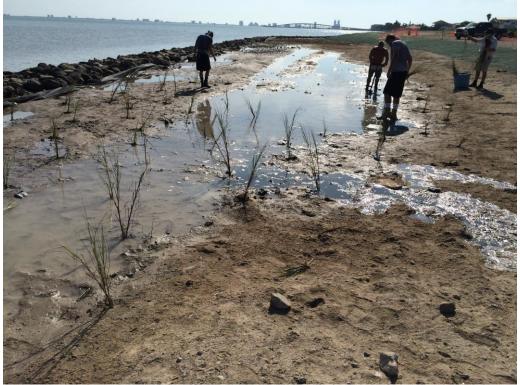
Subcontractor planting the marsh plants.
