Final Report

Restoration of multiple wetlands in the Magnolia Beach area, Calhoun County: Phase I Planning

The hydrological barriers as a cause of salt marsh loss

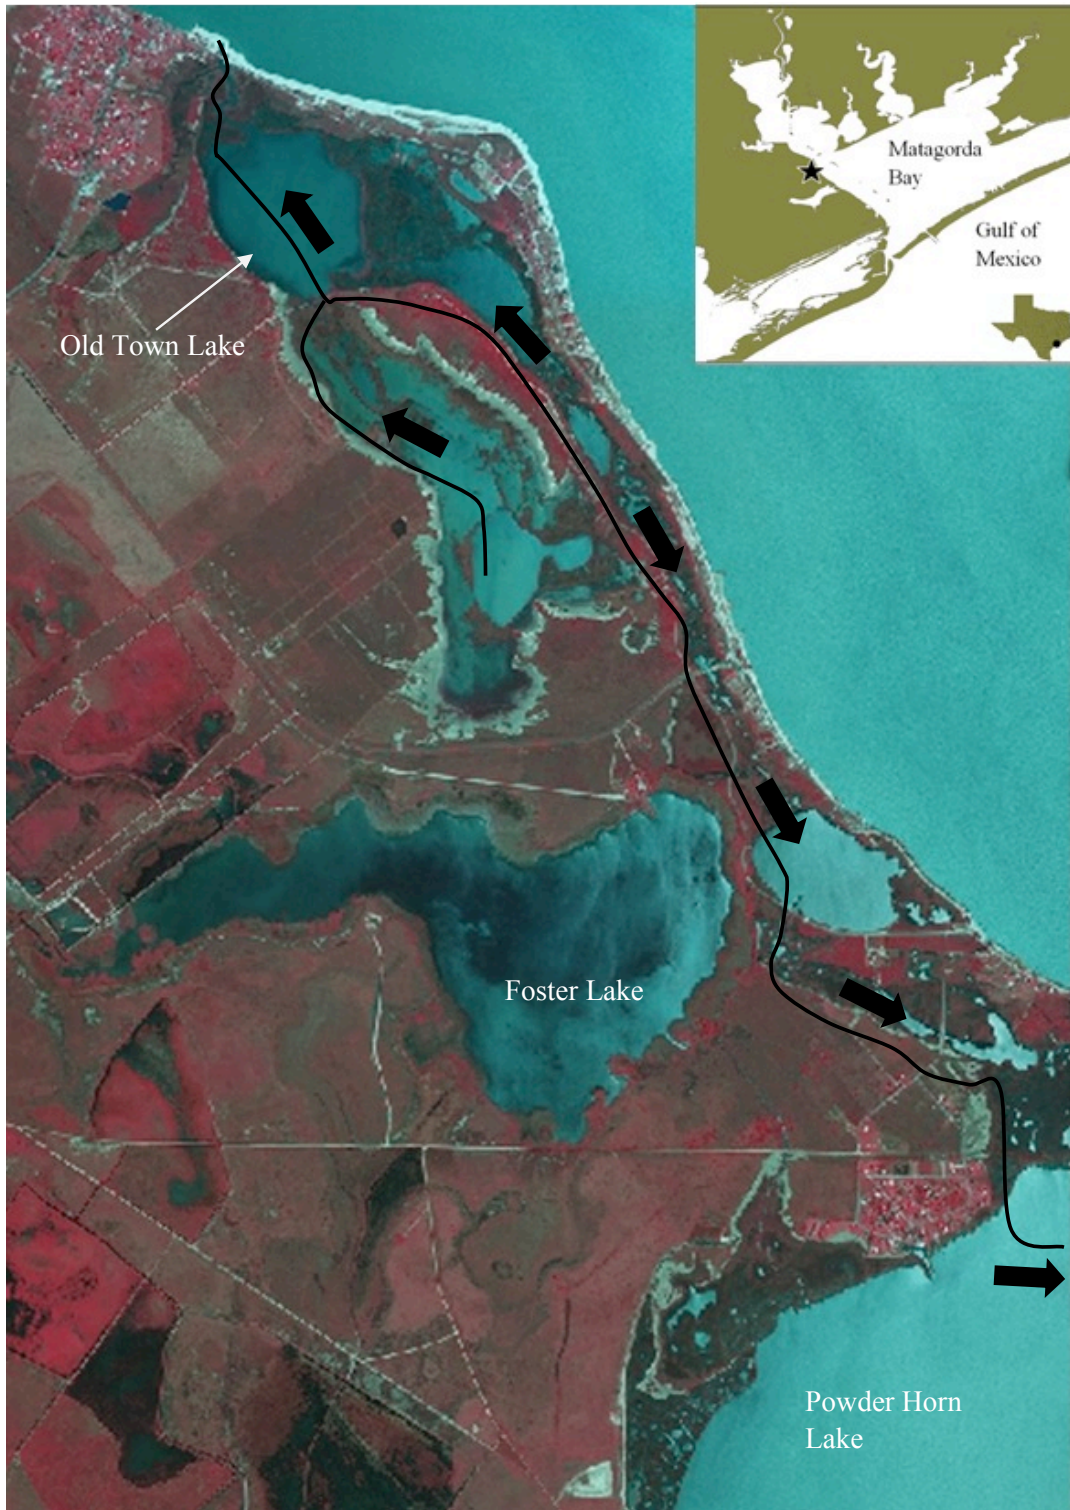
Fig. 1

Our study area is a complex of coastal salt marshes located on the west shore of Matagorda Bay near Indianola and Magnolia Beach, an area south of Port Lavaca, Texas (Figure 1). These marshes were historically connected to Matagorda Bay by at least two pathways; one natural inlet at the north end of the marsh known as Magnolia Inlet, and a second natural connection to the south that leads to Powderhorn Lake through an area known as Fish Pass.

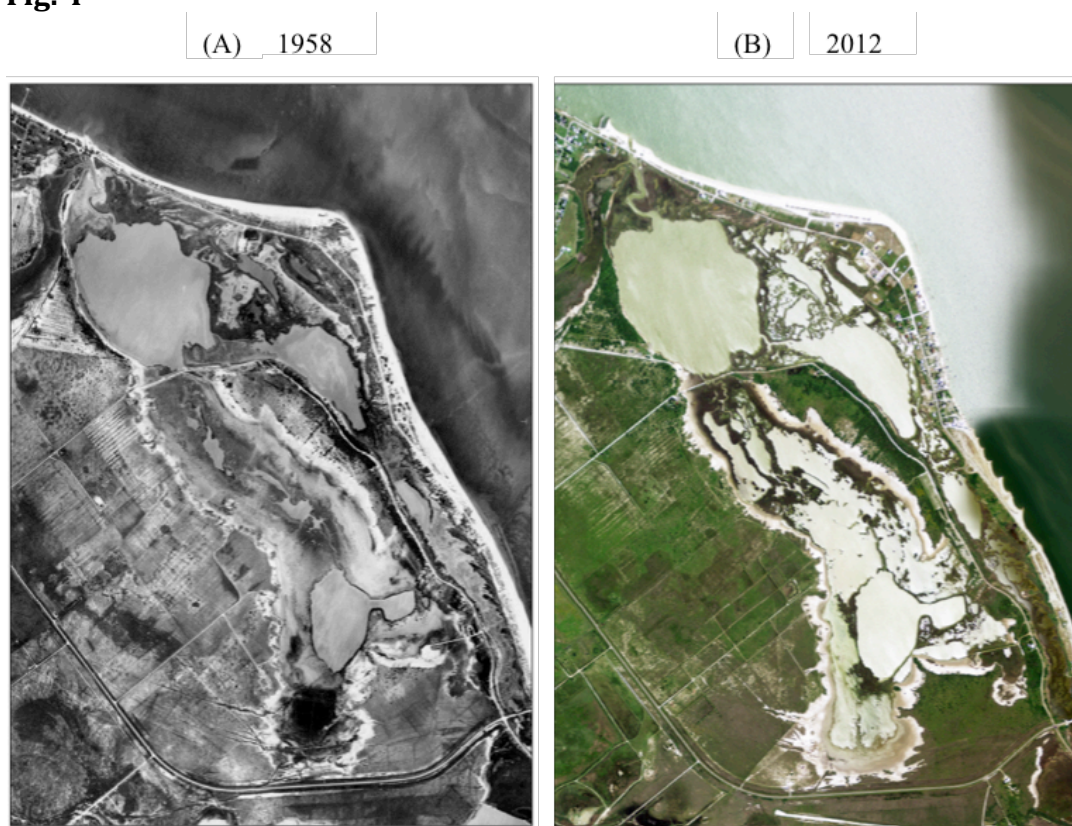
Fig. 4

The loss of the low marsh vegetation is likely correlated with the high salinity levels within the marsh (Figure 4). The majority of this low marsh is occupied by *Spartina alterniflora*, which suffers when salinity levels are higher than 325 mol m⁻³ NaCl (approximately 37 ms) (Adams & Bate, 1995; Naidoo, McKee, & Mendelssohn, 1992). Our records show salinities above this value nearly all of the time in Old Town Lake and the rest of the marsh, but also show salinities reaching up to 120 ms particularly in the portions of the marsh with the most loss, such as North Fish Pass. In particular, evaporation occurs in the summer during high temperatures, and this worsens the conditions for vegetation and nekton. The result is the low marsh is converted to open water.

To begin the reversal of this process of marsh loss, the past hydrologic processes that maintained the marsh must be restored. It was determined that the structure responsible for the modified hydrology is the shell and mud debris in Magnolia Inlet (Figure 4). This separation has caused reduced tidal action within the impounded marsh, resulting in extended periods of disconnection time. This process continues to inflate the salinity levels within the marsh until tidal inflow events are able to dilute the salinity levels within the marsh. Channelization of the shell and mud debris pile could improve the tidal action within the marsh and alleviate the elevated salinity levels. The connection will also allow for greater volumes of water to be exchanged, thus will help to more completely mix the vast volume of water.
